ENHANCED PRELIMINARY ASSESSMENT REPORT:

JEFFERSON PROVING GROUND
MADISON, INDIANA

March 1990

Ebasco Environmental
5000 Bradenton Avenue
Dublin, Ohio 43017

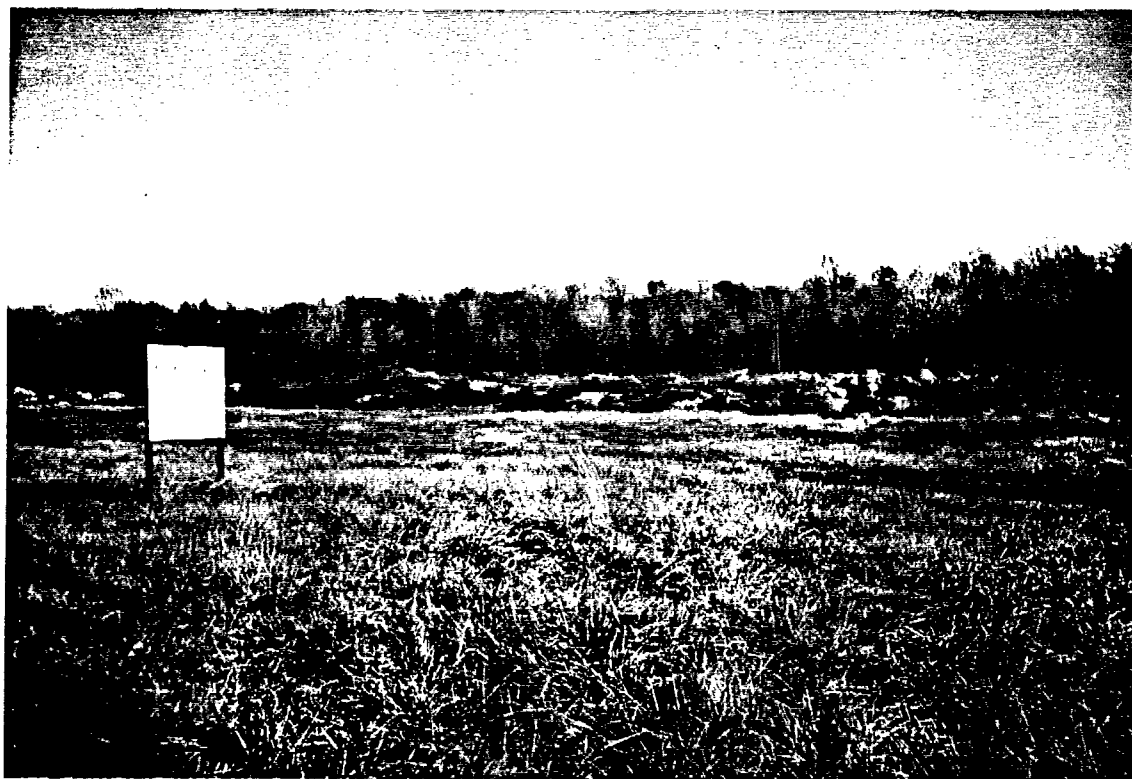
JPG-015 GATE 19 LANDFILL - Facing N; 11/13/89

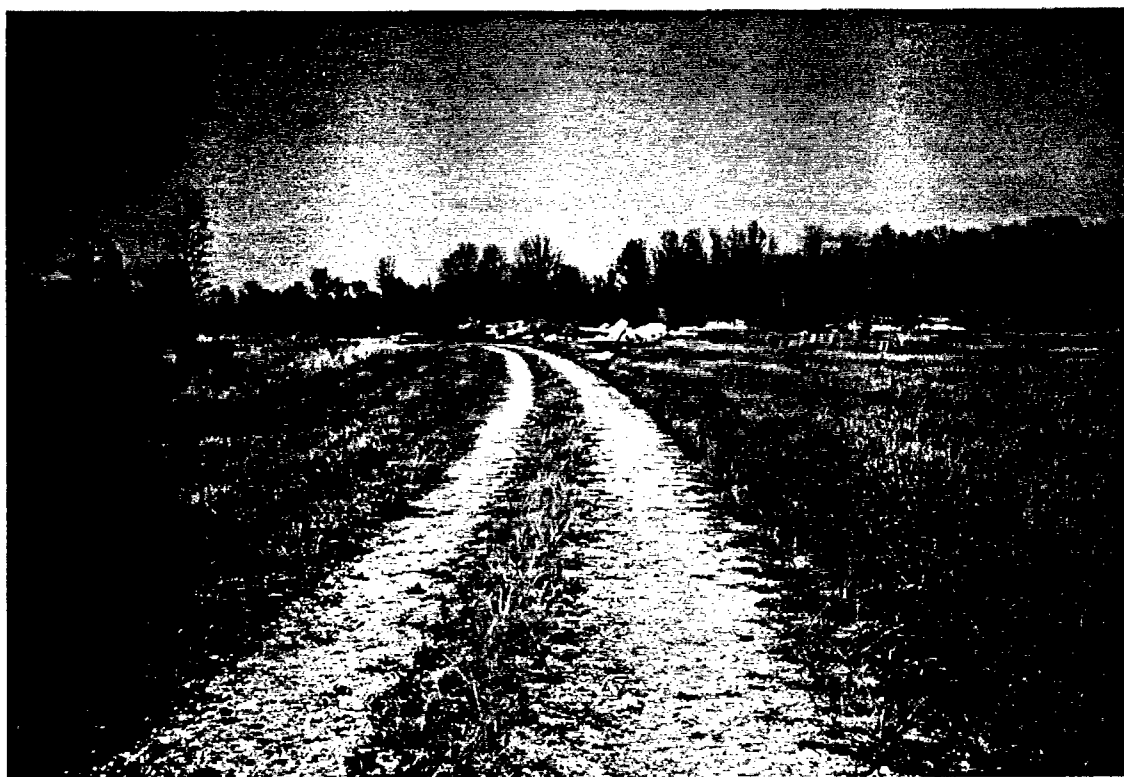
JPG-015 GATE 19 LANDFILL - Facing E; 11/13/89

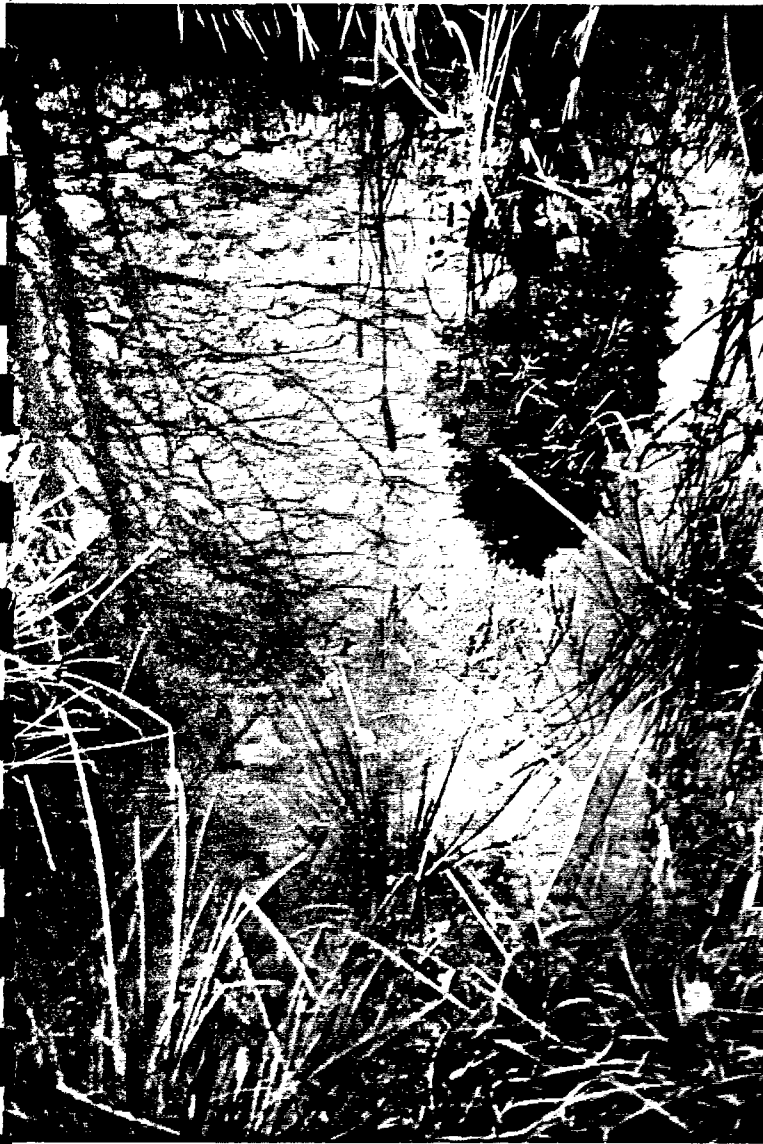
JPG-016 ORDNANCE DISPOSAL SITE; 11/14/89

JPG-016 ORDNANCE DISPOSAL SITE - Pit filled w/water; 11/14/89

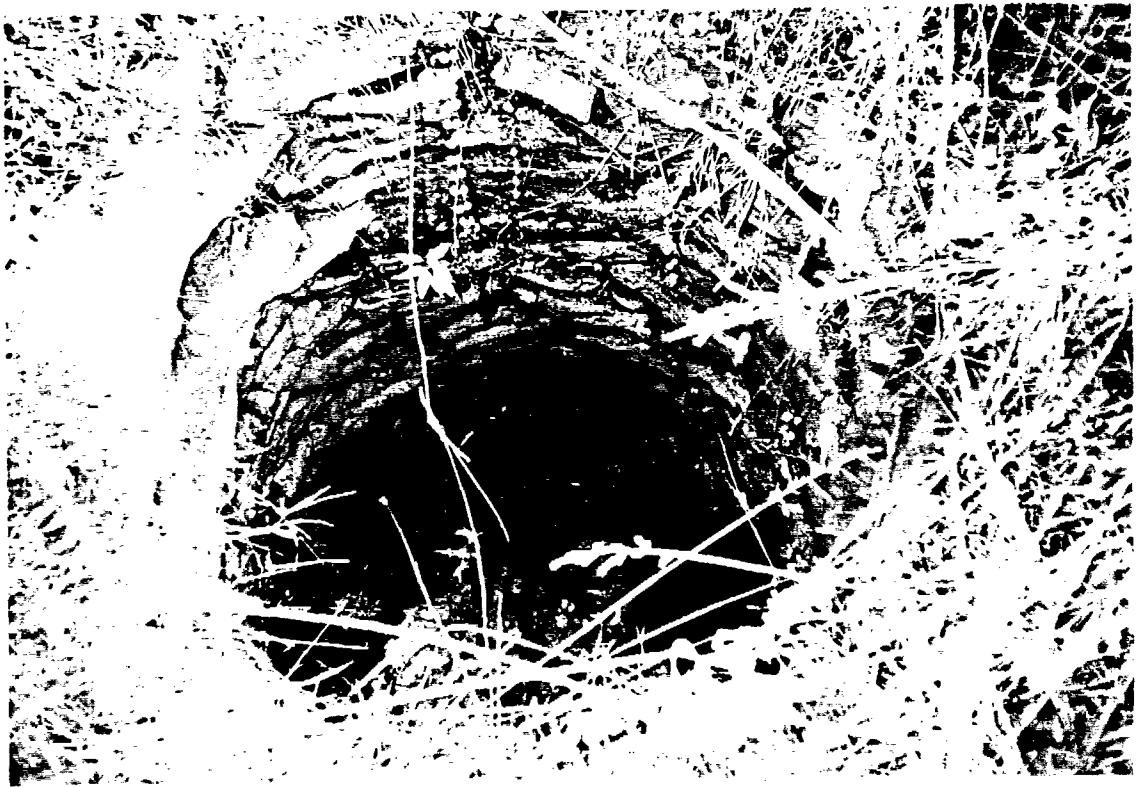
JPG-018 ABANDONED WELL DISPOSAL SITE; 11/14/89

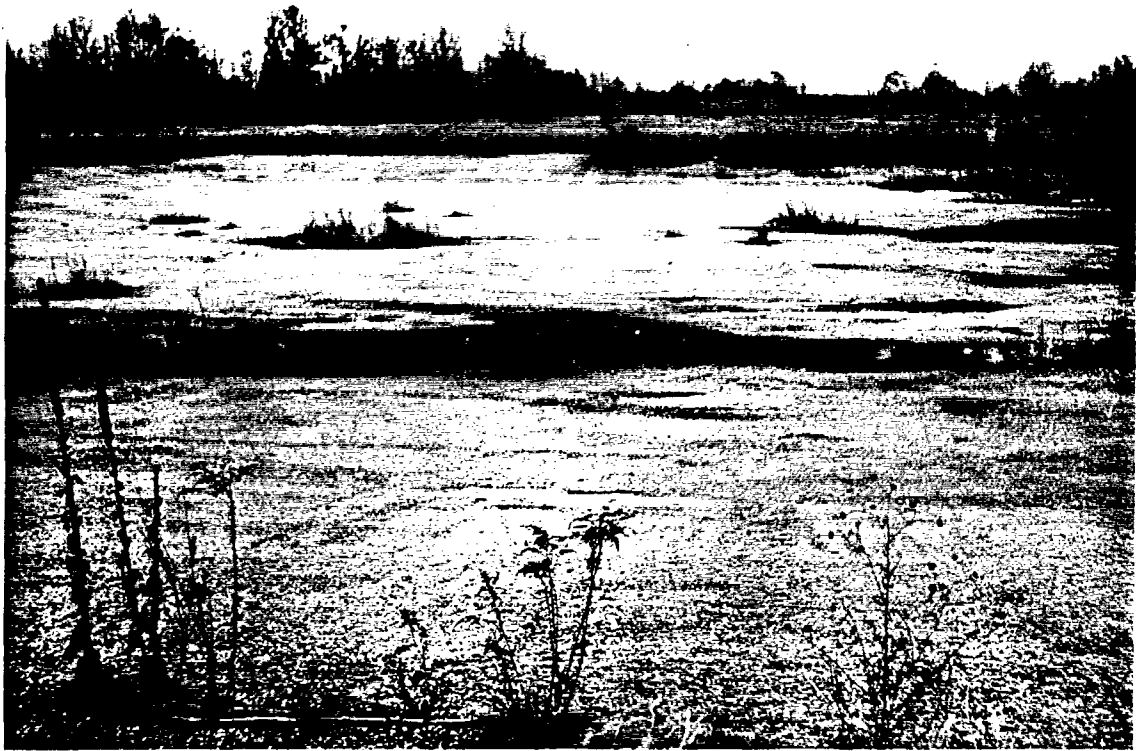
JPG-020 MACADAM TEST POND; 11/14/89

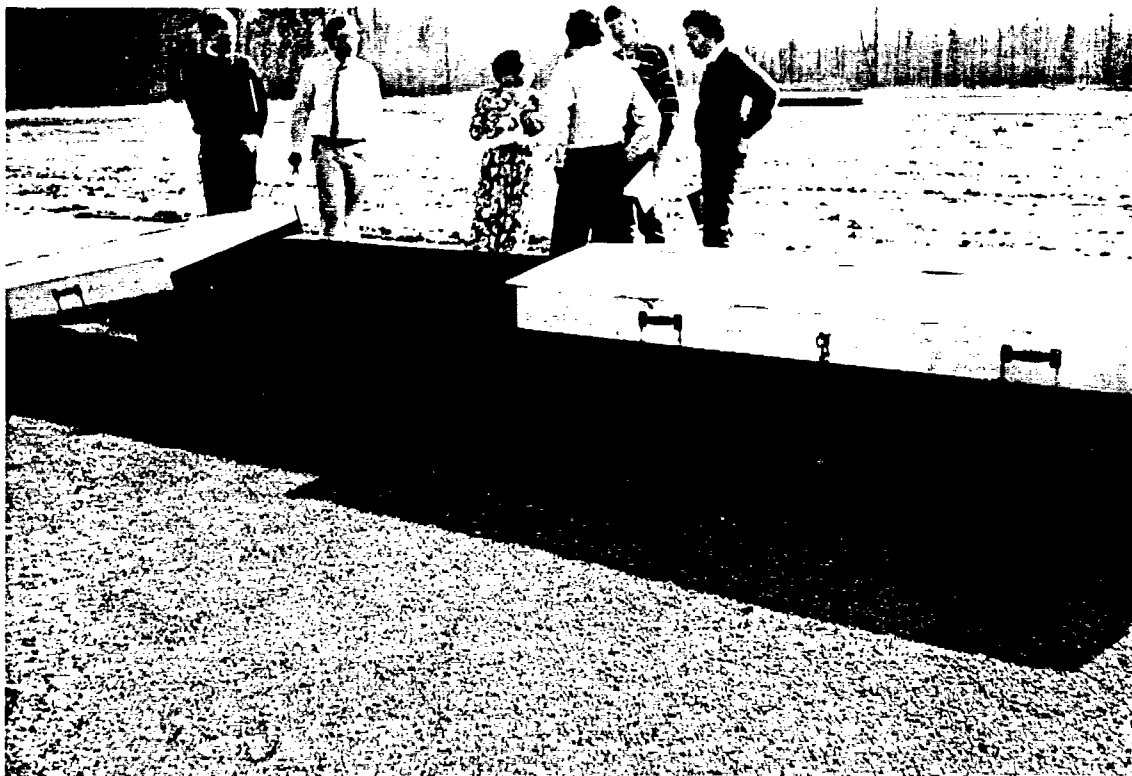
JPG-022 - Burning trays; 11/13/89

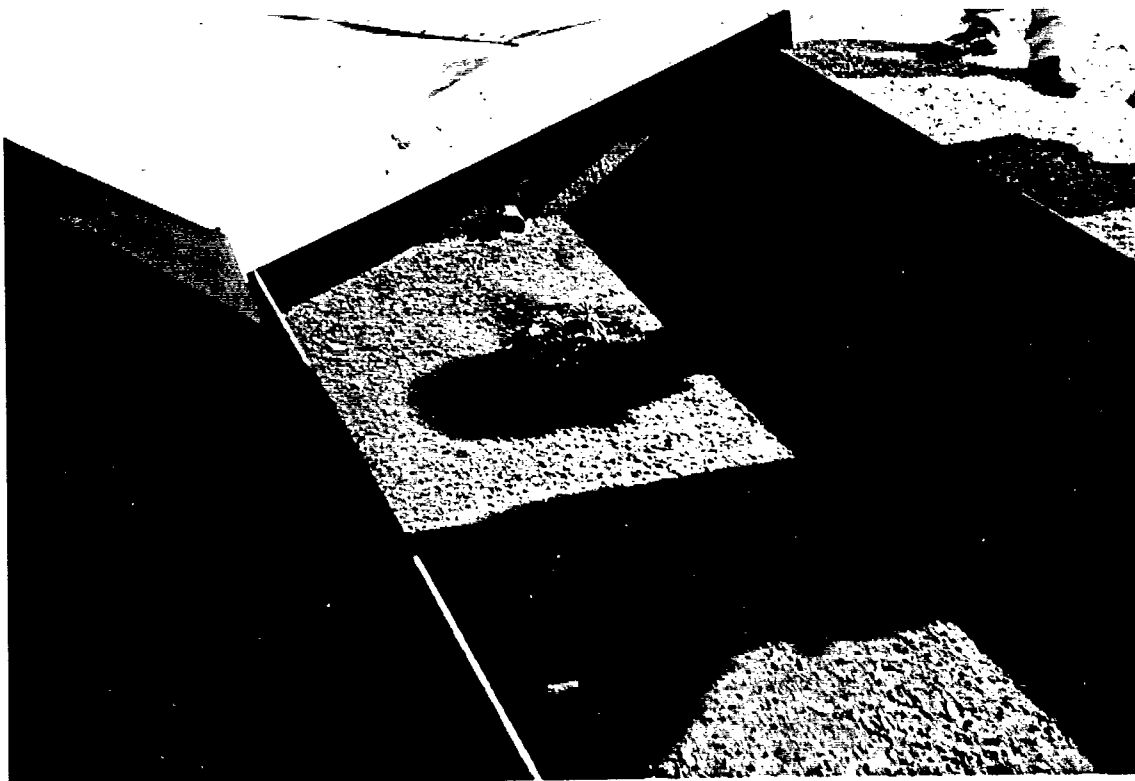
JPG-022 - Residue in burning trays; 11/13/89

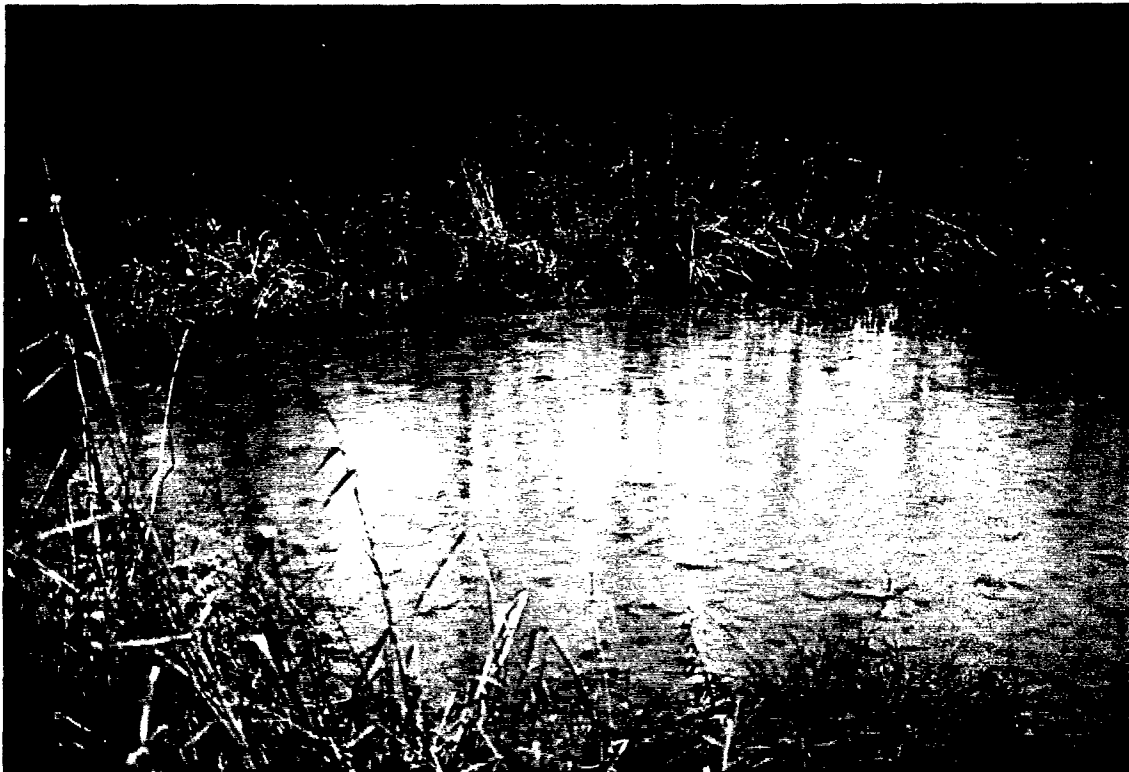
JPG-024, JPG-025 - Poned water; 11/14/89

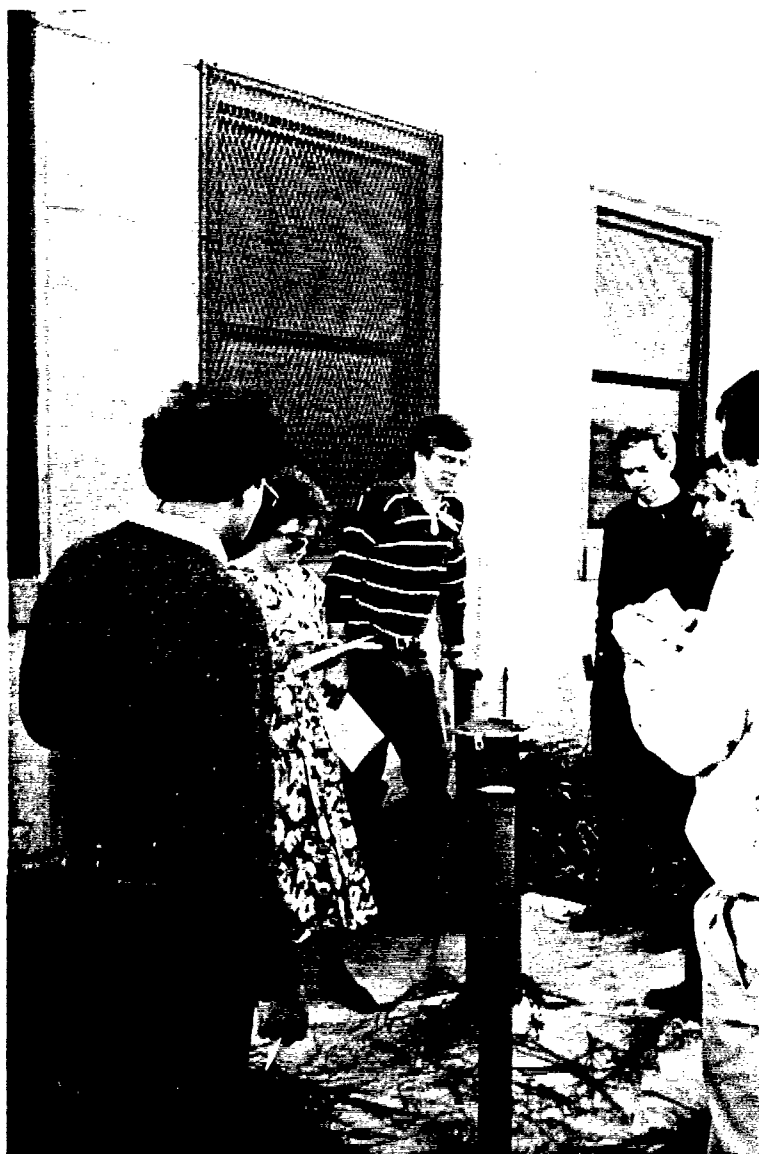
JPG-029 BUILDING 279 SOLVENT DISPOSAL AREA - MW15; 11/13/89

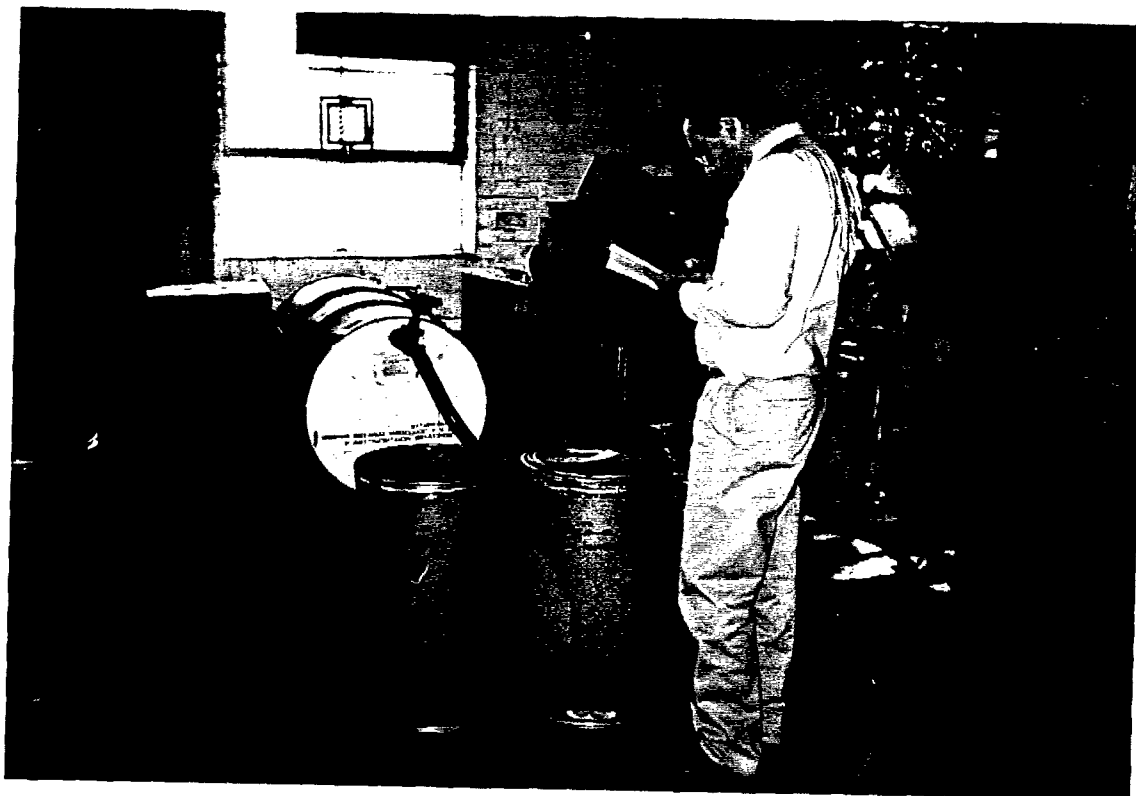
BUILDING 211 - Inert loading building; 11/13/89

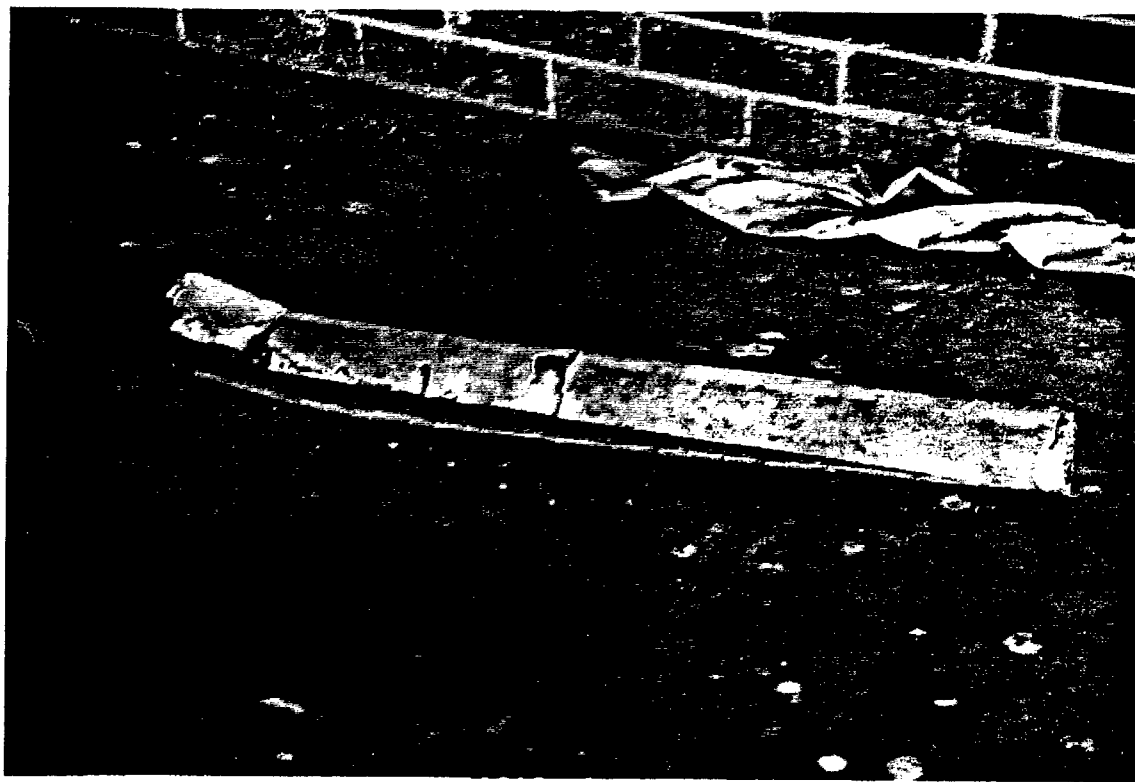
HANGAR - Facing North; 11/15/89

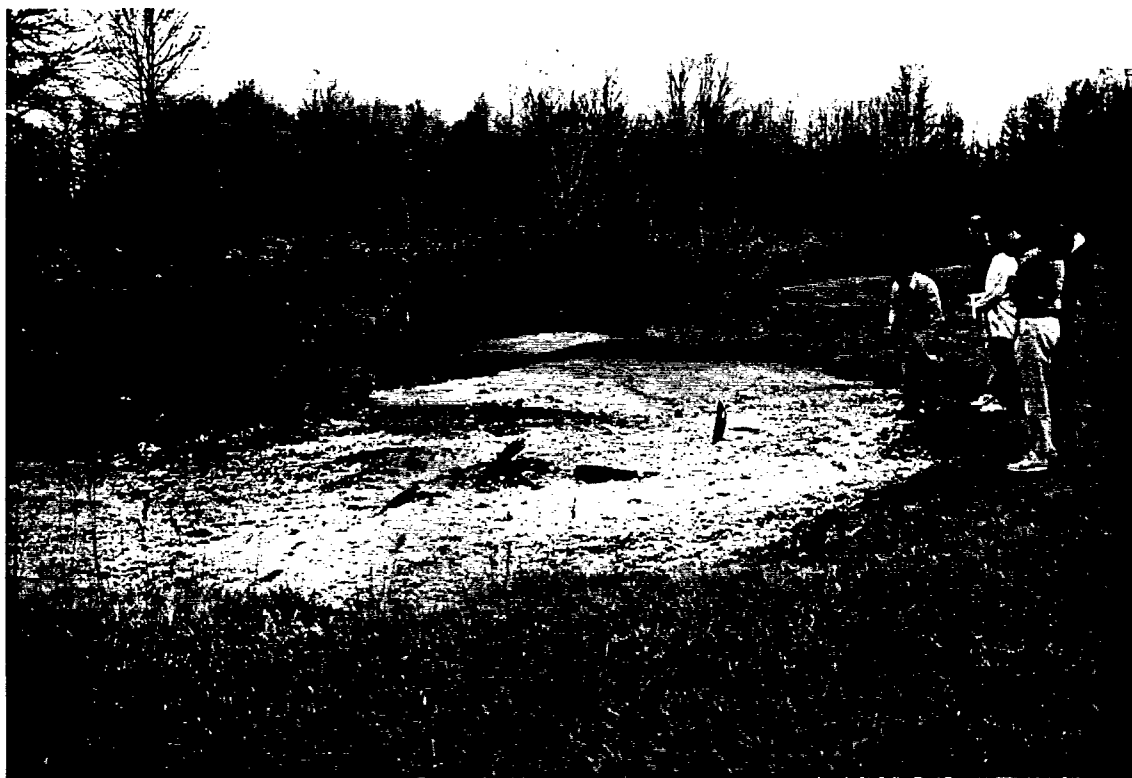
SULFUR PILE -Disposal area; 11/15/89

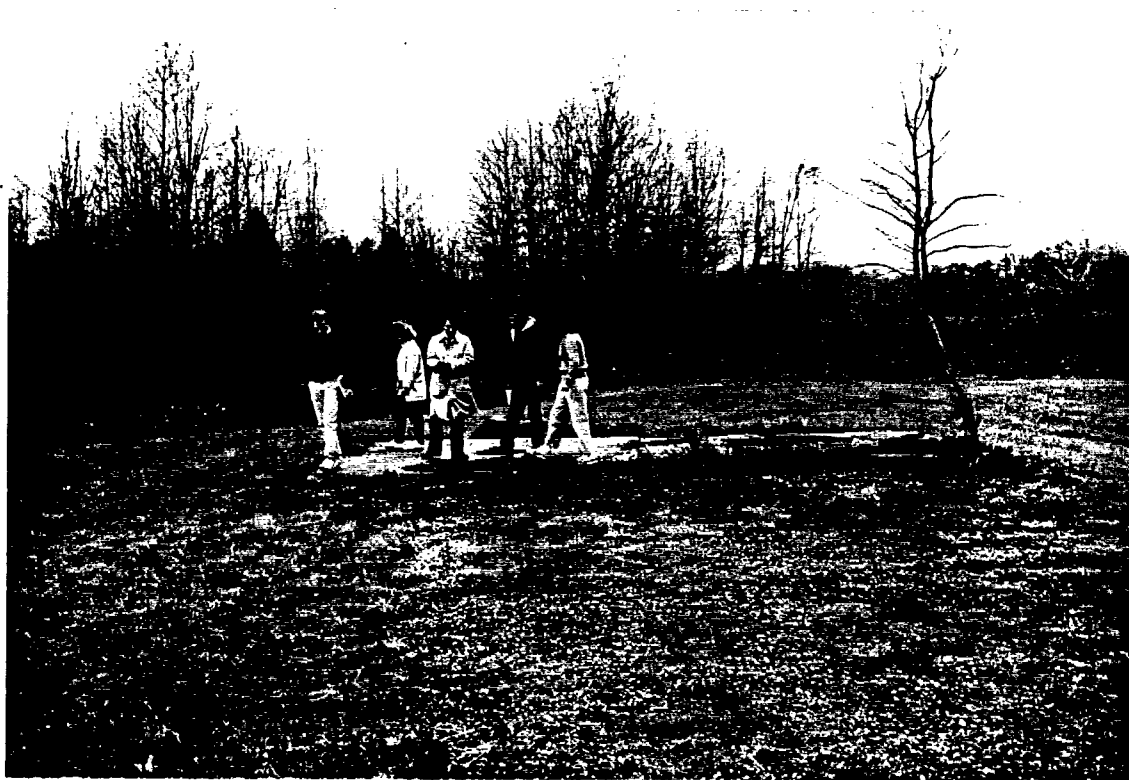
BURNED AREA - S. of the New Incinerator; 11/15/89
